# Transport for London

## PERS AUDITS 08/09 Phase Four

South – Lewisham, Greenwich,  
Bexley  
A205 Forest Hill Station to  
Catford Gyratory

### Final Report

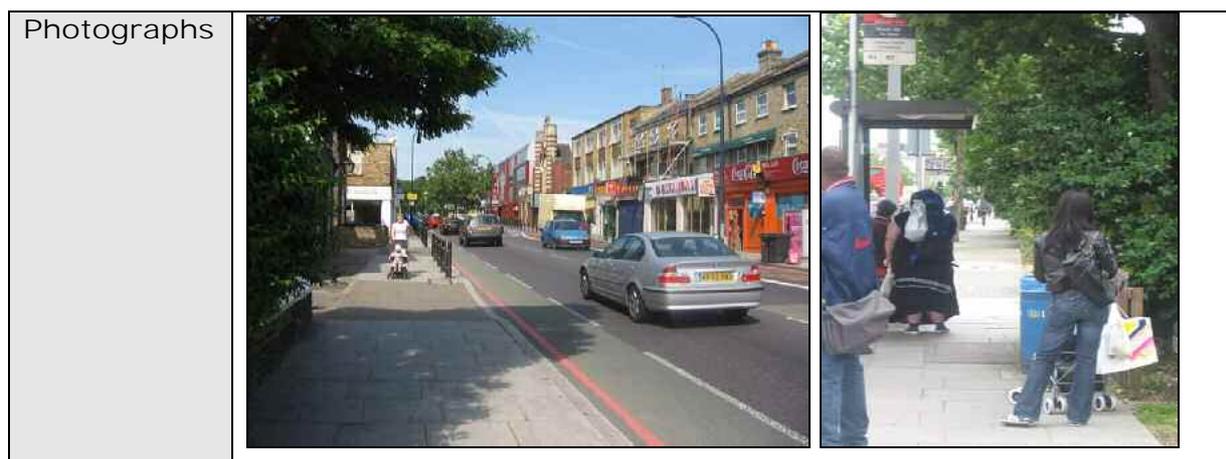
Descriptor	A205 southside from opposite Wastdale Road to Cranston Road
Ref	L5
RAG & Total Score	-5
Comments	<p>The <u>permeability of this link is again poor</u> owing to <u>high traffic flows and speeds</u> on the A205. A <u>lack of formal crossing points</u> and the presence of <u>pedestrian barriers</u> reduces permeability further. In addition, pedestrian movement is constrained by the <u>reduction of effective width by PT10 and associated queues</u>, and the placement of wheelie bins and sign posts. Overhanging branches also create <u>overhead obstructions</u> in places. <u>User conflict is caused</u> by the location of the bus stop on the link and by cyclists, who were witnessed using the footway at the time of audit.</p> <p>There is <u>no pedestrian signage on the link</u>, and although there is <u>good tactile provision</u> there is a serious trip hazard created by <u>uneven tactile</u> at Cranston Road. <u>Surface quality is poor</u> at a number of locations across the link with another <u>trip hazard at Kemble Road</u> and <u>undulations and inconsistencies</u> created by tree roots. Driveways create further undulations and the link is located on a <u>slight gradient</u> but <u>the only rest points are informal</u>.</p> <p><u>Street lighting is infrequent</u> with only two lamp posts focusing on the footway. <u>Personal security is generally good</u> however despite the <u>poor quality of the environment</u>, which is negatively impacted by the high traffic flows of the A205.</p>

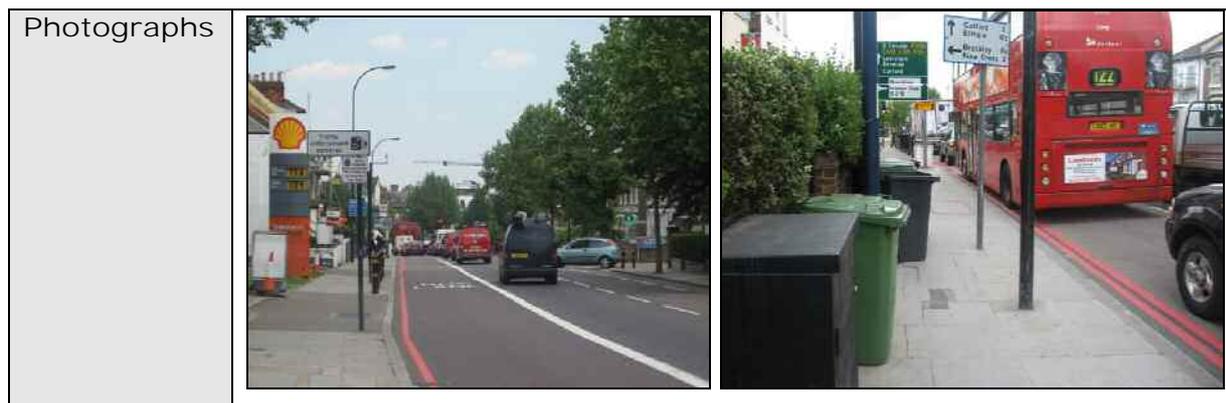
Descriptor	A205 northside from Brockley Rise to Colfe Road
Ref	L12
RAG & Total Score	-5
Comments	<p>There are no side roads on the link and <u>only one formal crossing of the A205</u> to the western side of the link, and as is the case on other links <u>high traffic speeds and volumes</u> make informal crossing problematic even for the most able bodied pedestrians. Permeability is therefore poor and pedestrian movement is hampered further by <u>heavy obstructions in parts of the link</u> with wheelie bins, signposts and shop displays reducing effective width in places. Low pedestrian flows suggest that <u>pinch points are not likely to lead to user conflict</u>, although <u>cyclists were seen using the footway</u>, which could cause problems.</p> <p>Traffic signage may assist navigation, although there is <u>no pedestrian signage</u>. <u>Tactile information is also limited</u> with no tactile alerting sensory impaired users to the exit and entrance of the Shell garage, and <u>confusing provision</u> at the junction of the A205 with Brockley Rise where tactile for <u>C11, C13 and C47</u> almost overlap. Little use has been made of colour contrast, which may help the navigation of sensory impaired pedestrians.</p> <p>The quality of the environment is relatively poor as <u>soft landscaping measures are limited</u>, some <u>frontages appear relatively neglected</u> and have <u>low aesthetical value</u>, and the traffic from the A205 has a negative impact in terms of noise and air quality. The <u>poor quality of private frontages</u> implies neglect, and may feel <u>unsettling at night</u>. There is also <u>no CCTV or visible police presence</u>, although <u>levels of activity are high during the day</u>. The perception of neglect extends to the footway surface. A number of <u>paving slabs are severely cracked</u>, there are <u>undulations and raised utility covers</u>, and evidence of <u>some pooling of water</u>. <u>Debris has also accumulated</u> in places.</p>

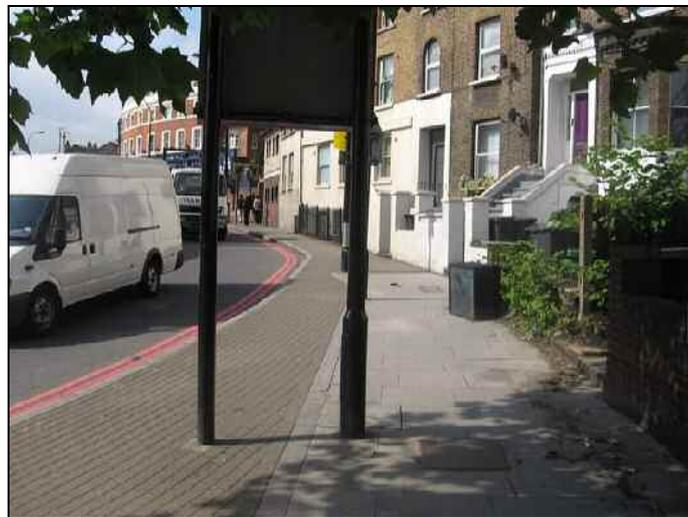
Plate 4.1: Traffic signage obstructs pedestrian movement on L15

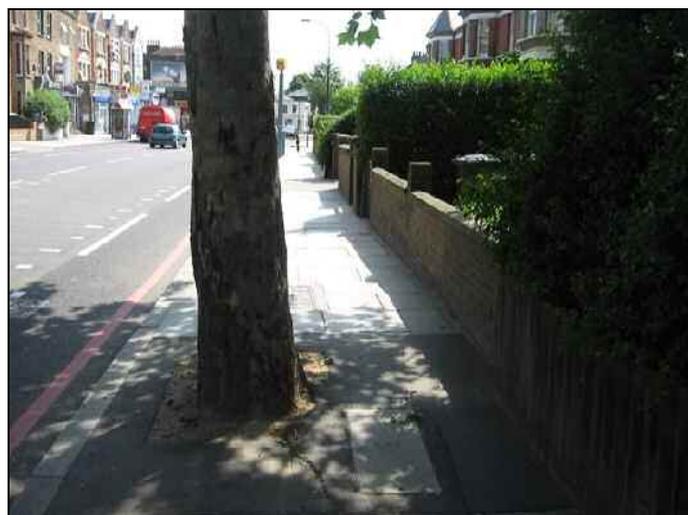
The majority of street trees in the audit area are well aligned but some, such as those on L7 (A205 southside from Hurstbourne Road to Blythe Road), also obstruct, as shown in Plate 4.2 below.

Plate 4.2: Street trees obstruct sight lines and pedestrian flow on L7

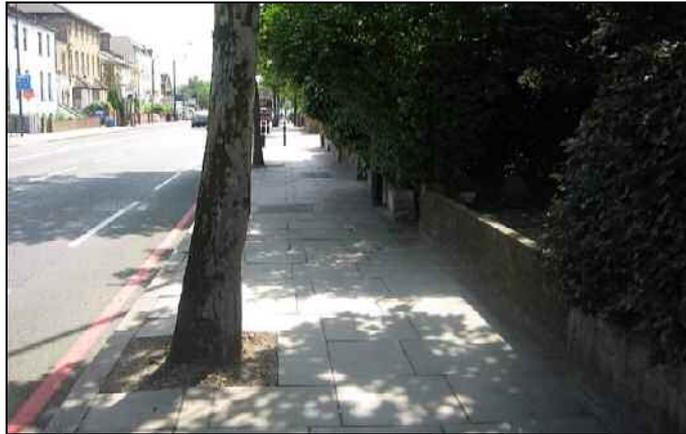
Plate 4.3: Effective width is reduced by street trees and overhanging foliage from residential properties on L5

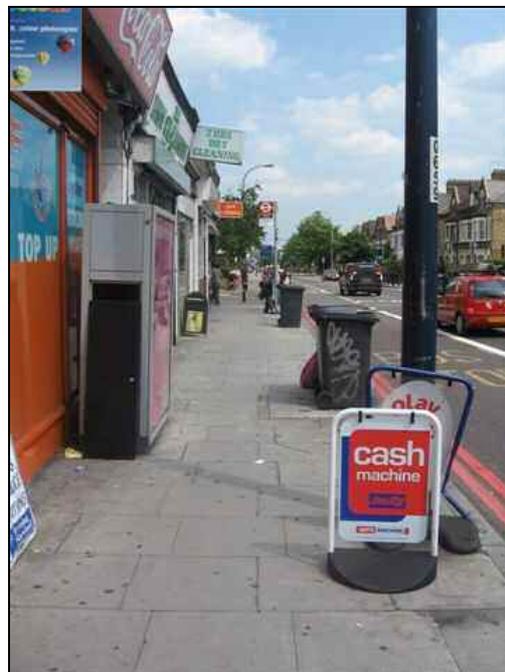
Plate 4.4: Wheelie bins and A-boards associated with retail land reduce the effective width of L13

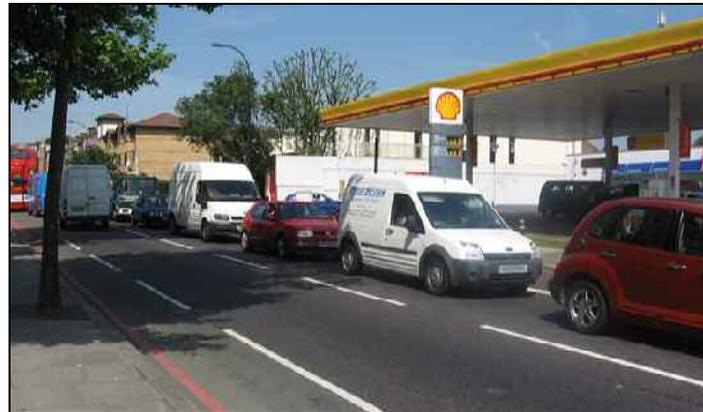
Plate 4.5: High levels of traffic flow reduce permeability across the site (L5)

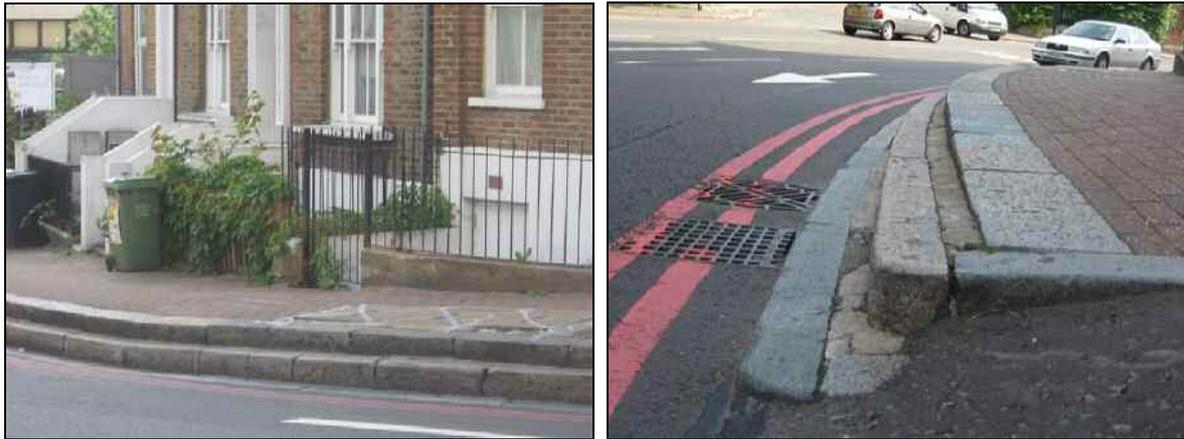
Plate 4.6: Stepped kerbs reduce permeability on L1

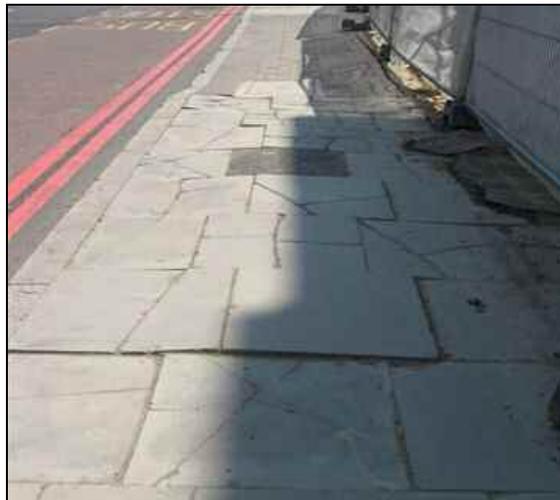
Plate 4.7: Cracked, uneven and inconsistent footway surface on L7

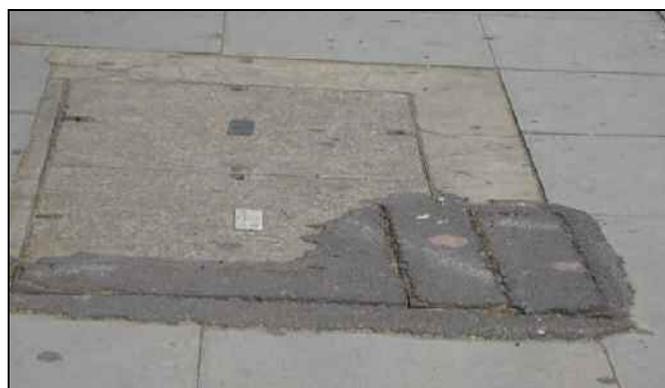
Plate 4.8: Poor quality reinstatement on L12

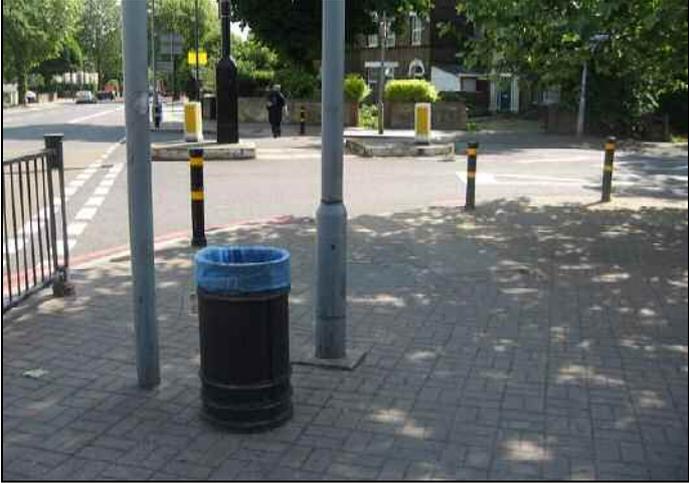
<p>The <u>poor alignment of traffic signage</u> and a <u>litter bin obstructs pedestrian movement</u> along <u>L2</u> (A205 southside from Waldram Place to Westbourne Drive) and <u>requires pedestrians to deviate</u> on the approach to <u>C5</u> (Across Westbourne Drive southside of A205).</p>

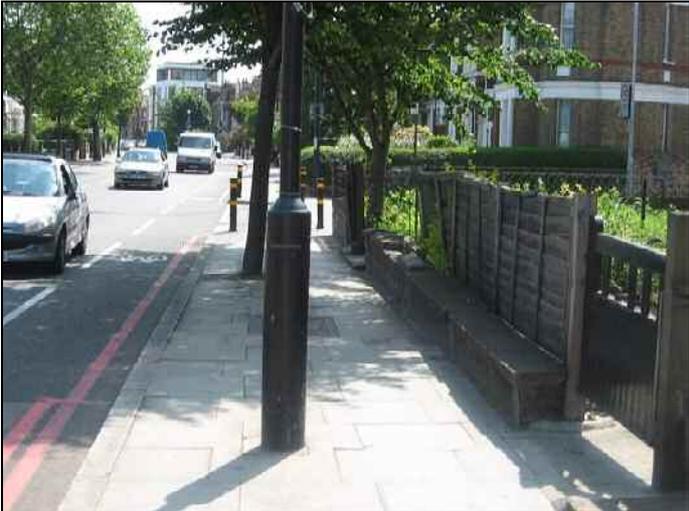
<p><u>Poorly aligned lamp posts</u> on <u>L6</u> (A205 southside from Cranston Road to Hurstbourne Road) <u>effectively halve effective width</u>.</p>

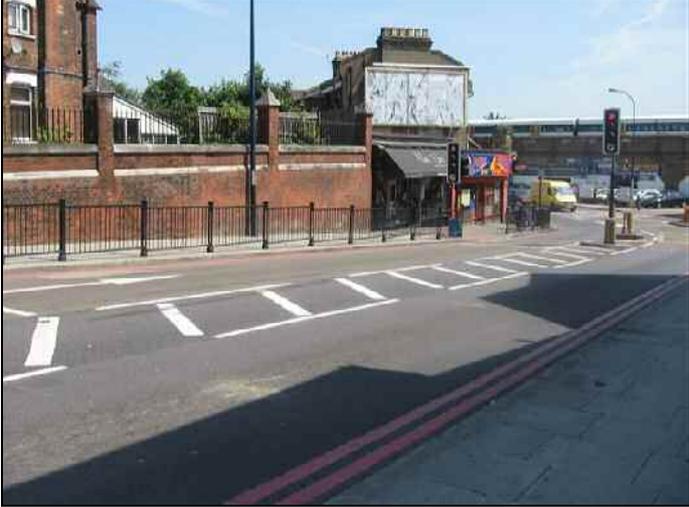
<p><u>Guard railing</u> on <u>L9</u> (A205 northside from Catford Hill to Stanstead Grove) severely <u>reduces the permeability</u> of the link, particularly in proximity to St. Dunstan's College.</p>

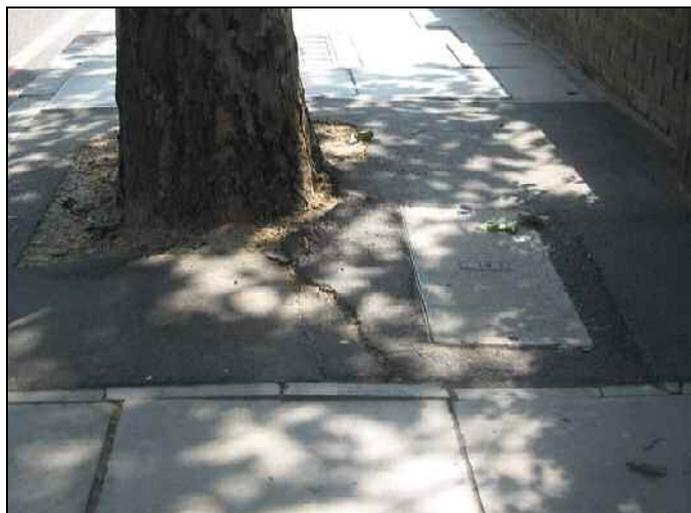
The roots of street trees on L7 (A205 southside from Hurstbourne Road to Blythe Road) create cracks and undulations in the footway surface, which results in trip hazards in places.

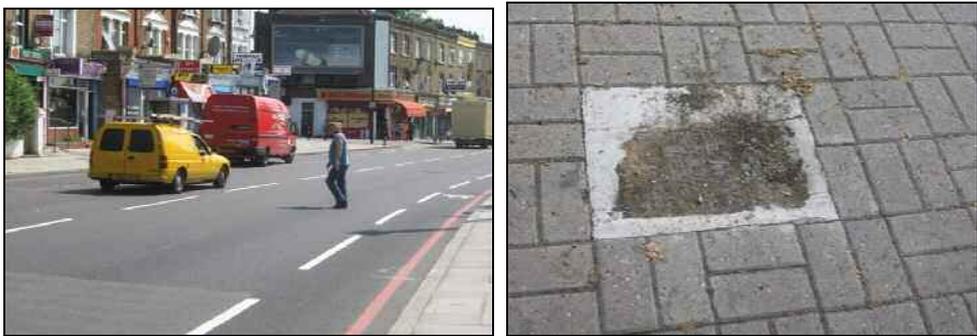
Descriptor	Informal across A205 from between the library and Carholme Road to parade of shops opposite	
Ref	C40	
RAG & Total Score	-41	
Comments	<p>A <u>high volume of vehicles</u> travel through this informal crossing area, which is on the desire line to the parade of shops around Ravensbourne Road, at speed. There are <u>no traffic control or pedestrian protection measures</u> despite the large deviation required to cross the A205 at formal crossing points. <u>Delay</u> experienced will vary with traffic flow, but it is likely to be considerable, particularly as <u>few vehicles were witnessed slowing for pedestrians</u>. The lack of provision for sensory and mobility impaired users mean that this crossing point is <u>only adequate for able bodied pedestrians</u>. <u>Parked vehicles can obstruct both sightlines and crossing</u>, and pedestrians may deviate around a <u>potential trip hazard on the northern side</u> of the crossing. Surface quality is otherwise generally good.</p>

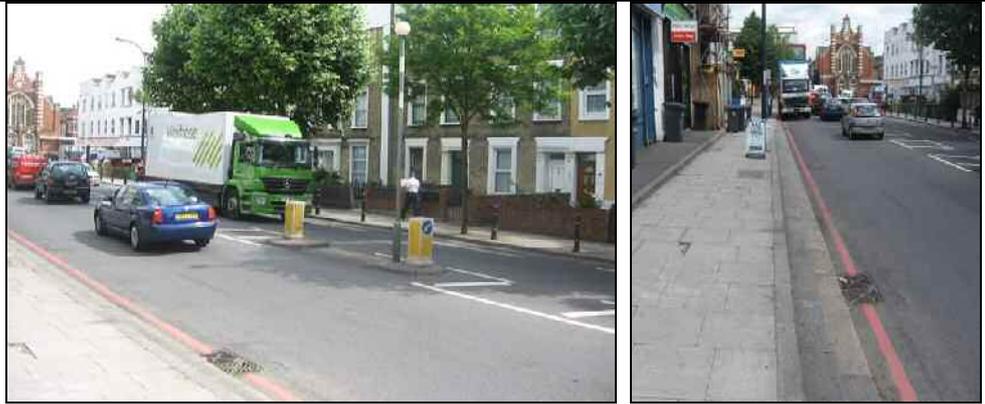
Descriptor	Informal across A205 west of the junction with Sunderland Road
Ref	C50
RAG & Total Score	-42
Comments	This stretch of carriageway experiences <u>high volumes of traffic travelling at speed</u> . There is a general <u>lack of provision</u> owing to its informal status, although the <u>traffic island affords a small degree of protection</u> to pedestrians crossing at this point. The crossing is located on a desire line, <u>although bollards and a street tree to the eastern side of the crossing area could obstruct the path of some pedestrians</u> . <u>Parked vehicles and a bend in the carriageway</u> to the south of the crossing area makes crossing here particularly hazardous as <u>sightlines for both pedestrians and vehicles are partially blocked</u> . Both <u>crossing and wait times are likely to be long</u> . The <u>lack of provision and stepped nature of the dropped kerb</u> to the western side of the crossing make this crossing point <u>only suitable for able bodied pedestrians</u> .

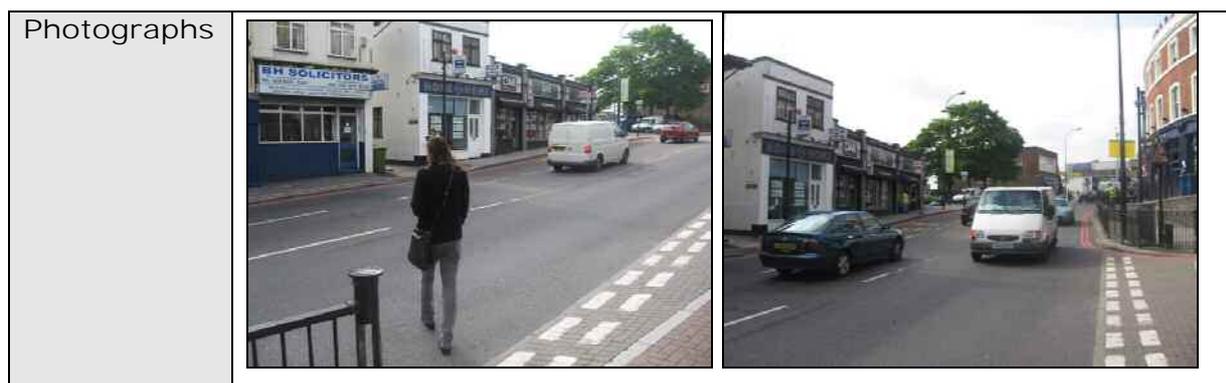
Descriptor	Informal across A205 outside Forest Hill Station
Ref	C56
RAG & Total Score	-71
Comments	This informal crossing traverses a relatively <u>wide stretch of the A205</u> , which experiences <u>high traffic flows and vehicles travelling at speed</u> . Unlike most informal crossings pedestrians are required to negotiate <u>guard railing</u> on the northern side of the crossing, which appears to have been located to prevent pedestrians crossing to the station at this point, which is made particularly hazardous owing to the <u>curve in the carriageway</u> to the east of the crossing, which <u>blocks sightlines</u> . The guard rails afford some protection, but there are <u>no other traffic control measures</u> . The traffic flow and obstructed sightlines result in <u>considerable delay</u> . <u>High dropped kerbs</u> (at some places reaching almost half a metre) and a <u>west to east gradient</u> further reduce the suitability of this crossing for all but able bodied pedestrians.

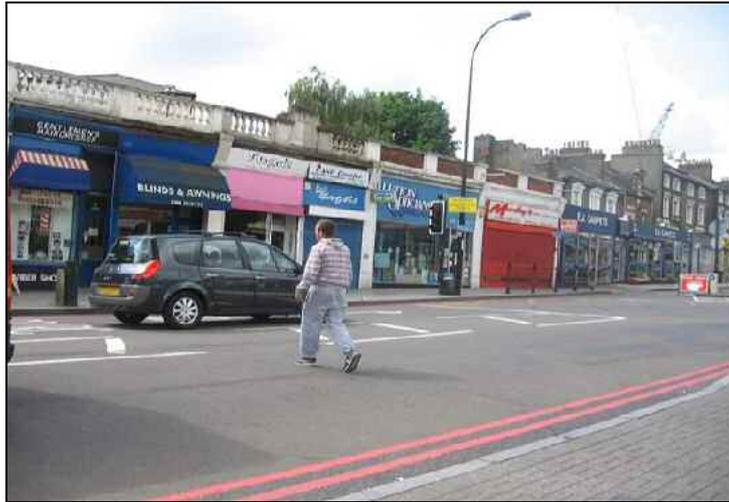
Plate 4.9: The lack of formal crossing provision at C52 leads to pedestrians weaving through traffic on a wide section of carriageway.

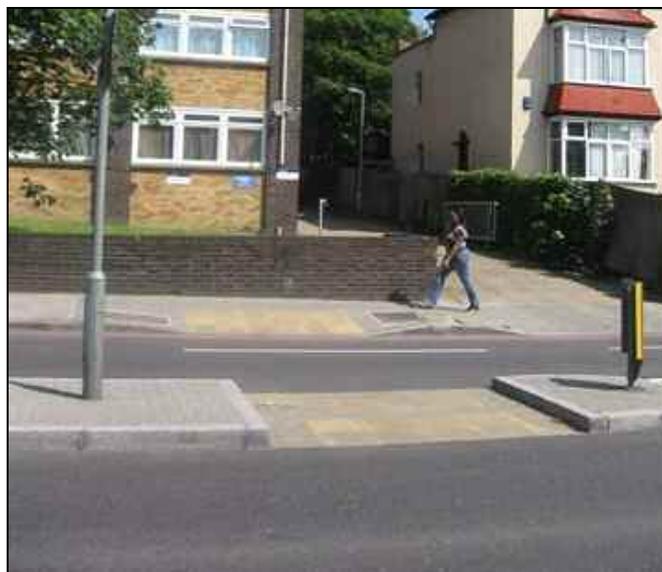
Plate 4.10: Lack of demarcation of the pedestrian crossing space on the carriageway leads to poor space ownership and vehicle behaviour at C20

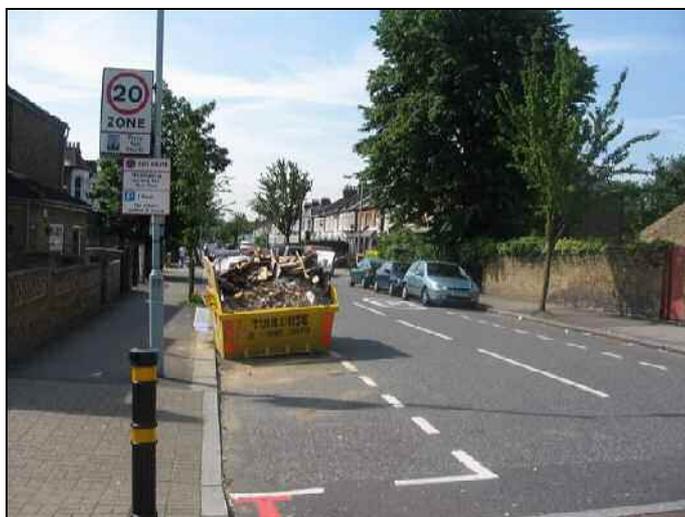
Plate 4.11: Sightlines are blocked on C11 by a skip and, at times, parked vehicles

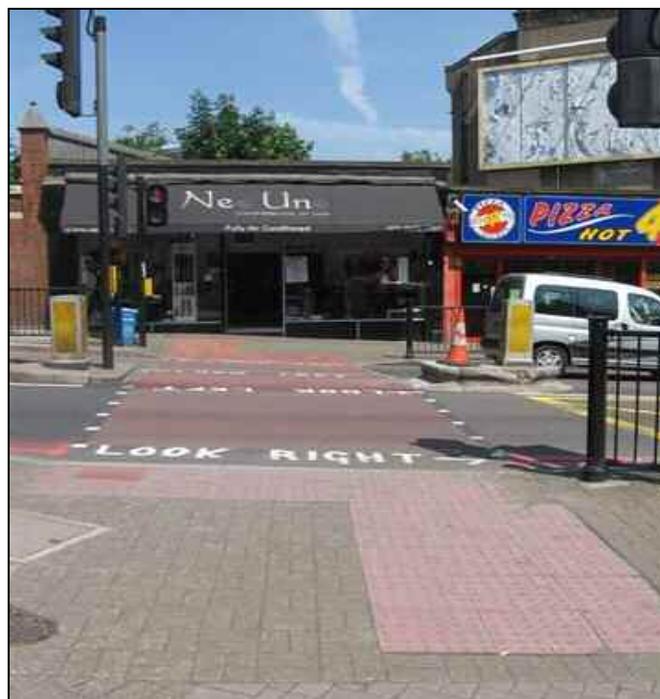
Plate 4.12: Vehicles queuing to join Catford Hill in proximity to C31

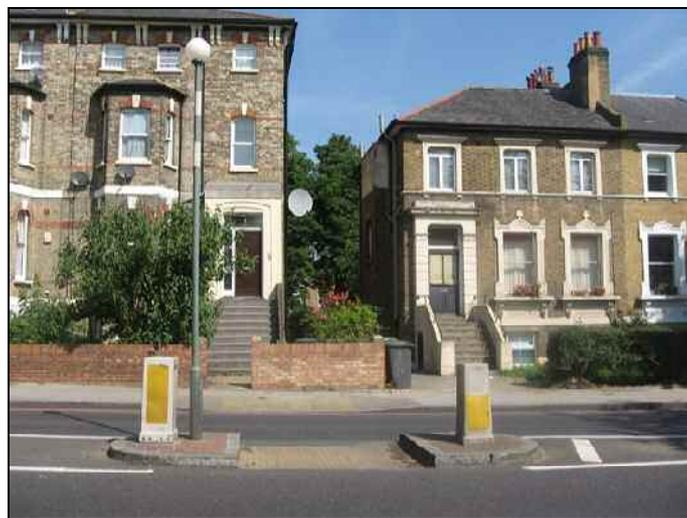
Plate 4.13: C7 traverses the A205 where traffic flows are high at a point where traffic speeds are also often high. Tactile provision could be considered to be inadequate as users are left to judge when it is safe to cross.

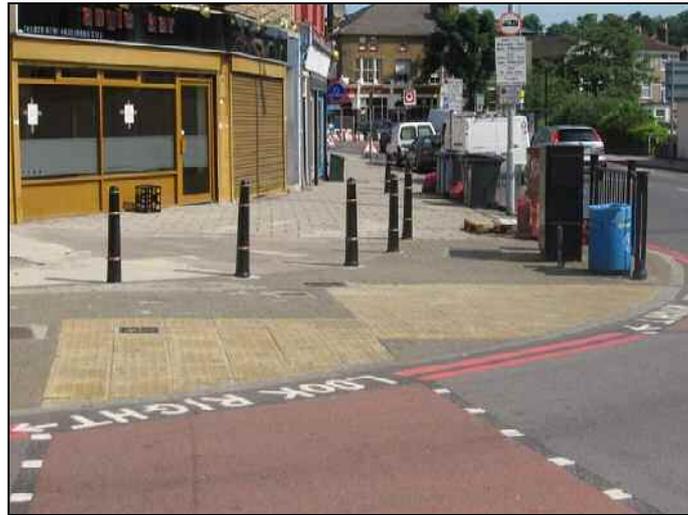
Plate 4.14: Tactile information for C12 and C46 merges, which could lead to confusion for some sensory impaired users.

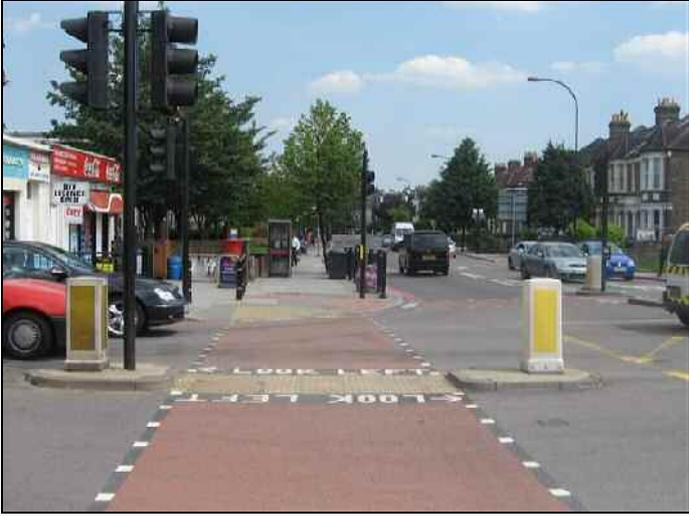
<p><u>Crossing provision</u> was considered to be inadequate at <u>C46</u> (Across B218 (Brockley Rise) northside of A205) as the <u>lack of pedestrian signals</u> makes it very <u>difficult to know when it is safe</u> to cross. The crossing is located at a <u>heavily trafficked junction</u> and has vehicles from three directions turning into the crossing area, but it is left to pedestrians to judge when to cross.</p>

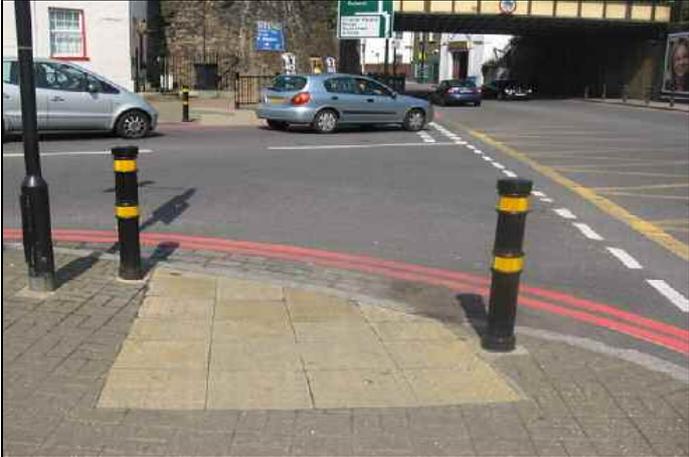
<p><u>Space ownership</u> is <u>poor</u> at <u>C2</u> (Across Waldrum Crescent southside of A205 (west)) owing to the <u>lack of demarcation</u> on the carriageway. The <u>absence of a driver stop line and clearly marked pedestrian area</u> can lead to vehicles queuing across the pedestrian crossing area thereby considerably <u>reducing the performance</u> of the crossing.</p>

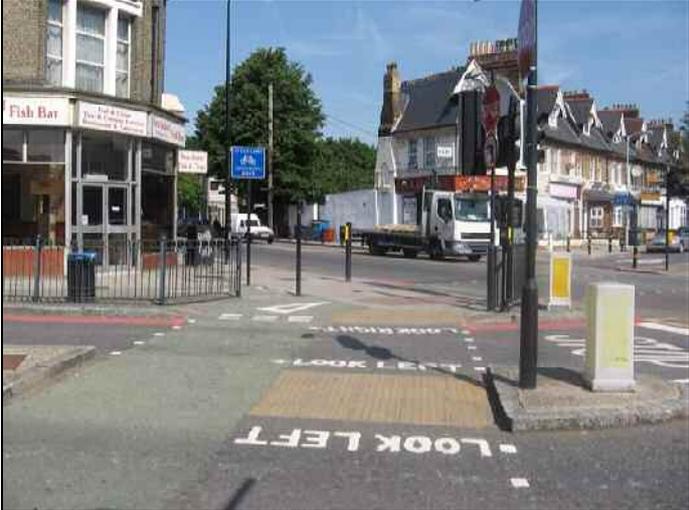
<p>Tactile information provision is good at <u>C4</u> (Across B277 Perry Vale southside of A205 (east)) but <u>may be difficult to detect and confusing to use</u> when approaching from the west owing to a cycle path dissectioning the exit of the crossing area. There is <u>no tactile warning to the presence of the cycle path</u>, which <u>could lead to conflict</u>.</p>

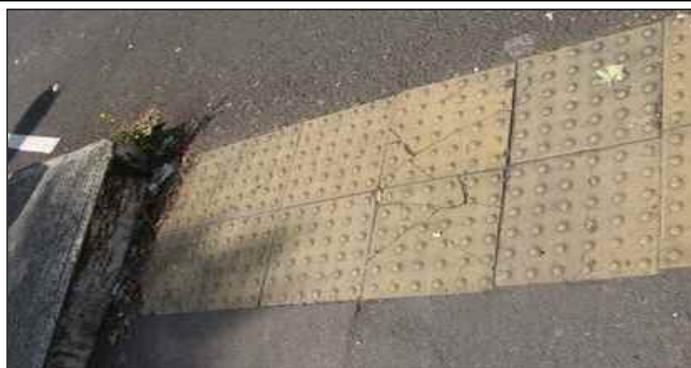
Cracked and uneven tactile information at C5 (Across Westbourne Drive southside of A205).

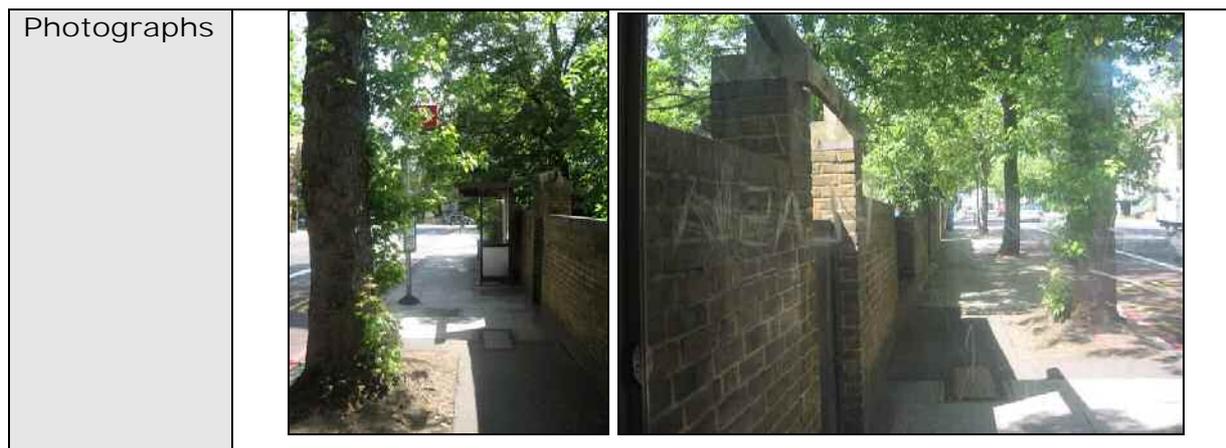
Descriptor	Bus stop J A205 southside, east of Church Rise
Ref	PT3
RAG & Total Score	-28
Comments	<p>The waiting area is situated on a footway with a wall behind and numerous trees providing <u>places for concealment</u>. These obstructions also <u>reduce sightlines</u> significantly so people waiting can't see others approaching. In addition there is <u>no CCTV or any telephones</u> to report incidents so <u>waiting passengers may feel vulnerable</u>. There is <u>some vandalism to the shelter</u> in the form of etching in to the Perspex sides. This also reduces the perceptions of safety here.</p> <p><u>Access to the waiting area is poor</u> as there are <u>no designated crossings</u> in the vicinity and therefore <u>no dropped kerbs or tactile to aid visually or mobility impaired users</u>. The surface of the footway is of good quality.</p> <p>The location of the shelter next to the busy A205 means <u>high levels of noise and air pollution</u> will degrade the environment for waiting passengers.</p>

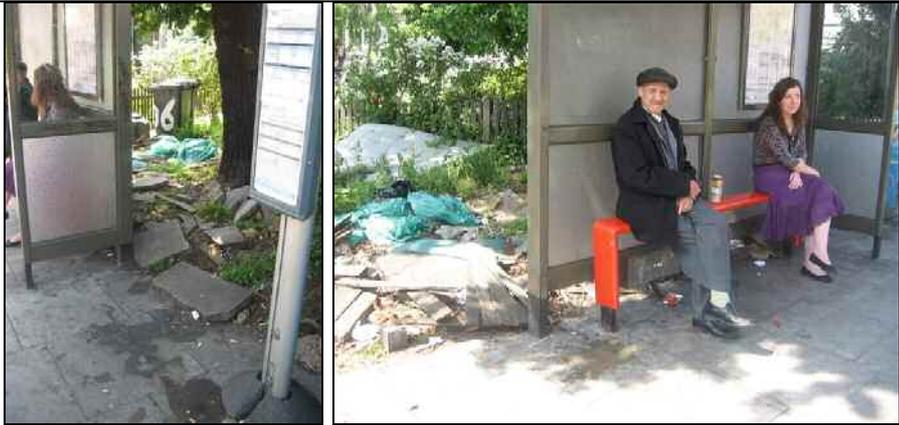
Descriptor	Bus Stop L A205 northside, east of Stanstead Road
Ref	PT15
RAG & Total Score	-25
Comments	<p>At the time of the audit PT15 had been partly destroyed in a collision. It is assumed that this was a vehicle collision. The waiting area subsequently has <u>no seating and parts of the shelter sides are missing</u>. Currently therefore there is nowhere to sit and little protection from the weather. In addition the <u>occurrence of the collision will be of concern to waiting passengers as it gives the impression it could happen again</u>.</p> <p>The quality of the environment is poor as the A205 is busy with high levels of noise and air pollution. There are <u>run down office buildings behind the stop which add to the poor quality of the environment</u>. <u>The stop is also in need of some maintenance and cleaning</u>.</p> <p>There is lighting around the stop although none specifically for the shelter and <u>many of the street lamps are obscured by trees</u>. <u>The waiting area could therefore be gloomy at night</u>.</p> <p><u>Infrastructure to the waiting area is poor with no formal crossings in the vicinity</u>. It could be dangerous to informally cross to the stop.</p>

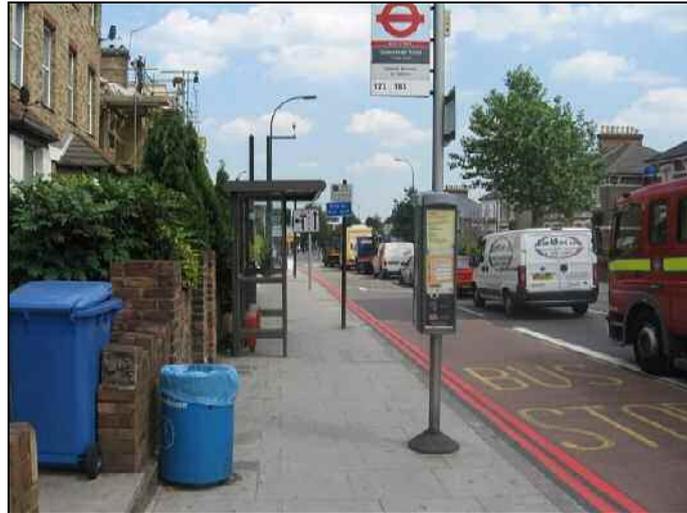
Plate 4.15: Queuing traffic at PT13 is very noisy and creates a high level of air pollution.

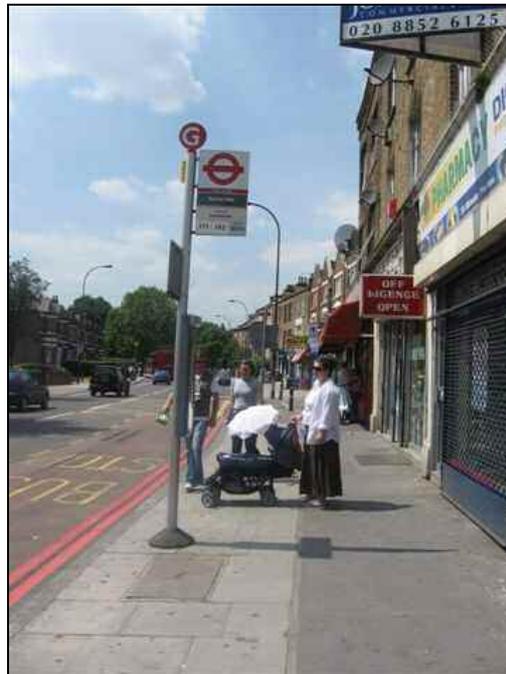
Plate 4.16: Closed shops behind PT10 reduce the quality of the environment at the bus stop and give the area a run down feel.

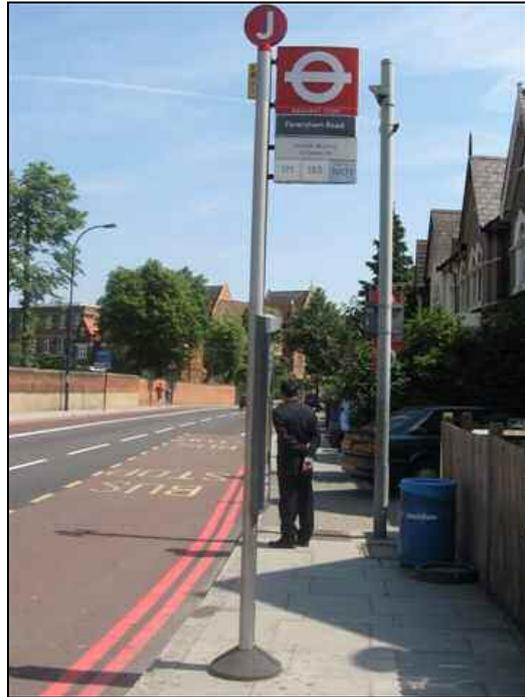
Plate 4.17: No shelter only a bus flag at PT8 have reduced the overall scores for waiting area comfort

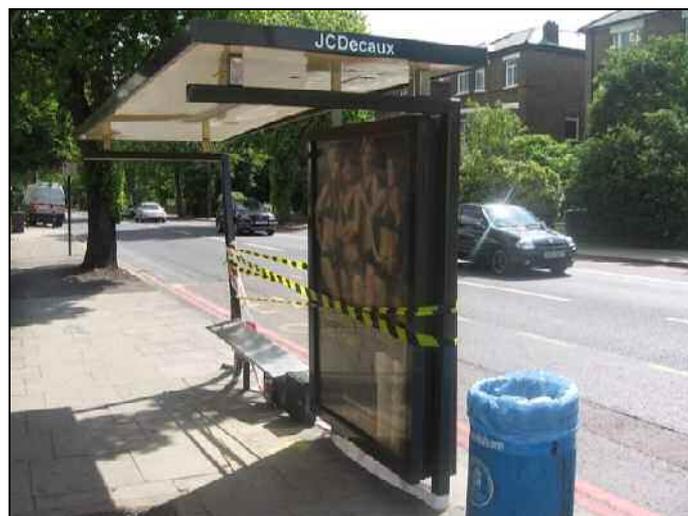
PT15 (Bus Stop L A205 northside, east of Stanstead Road) has been damaged severely, as a result the seating is missing and the shelter is taped off. The damage to the stop, as shown in Plate 4.18, may make users feel uncomfortable as it is not clear how the damage occurred or whether it could happen again.

Plate 4.18: Damage to PT15 has left the shelter without a seat and gives the impression of an unsafe place to wait.

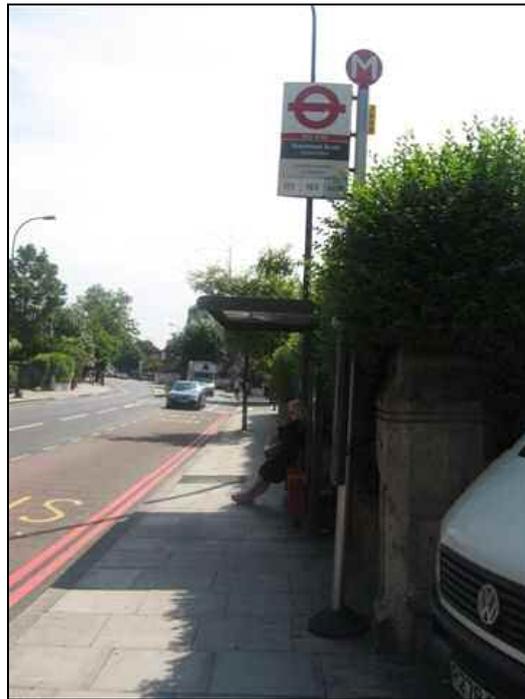
Plate 4.19: No crossing facilities in sight at PT5

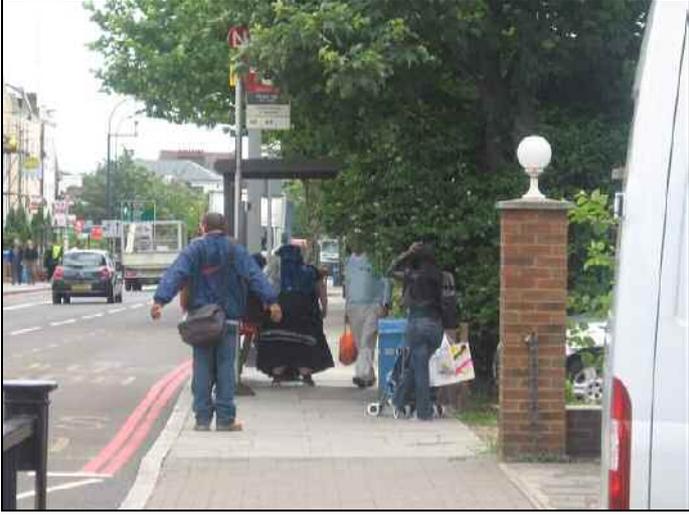
<p>A photograph showing a bus stop area on a sidewalk. Several people are walking, and a white van is partially visible on the right. The scene illustrates user conflict on approaches to waiting areas.</p>	<p>User conflict on approaches to waiting areas at PT4 (Bus stop N A205 southside, east of Kemble Road).</p>

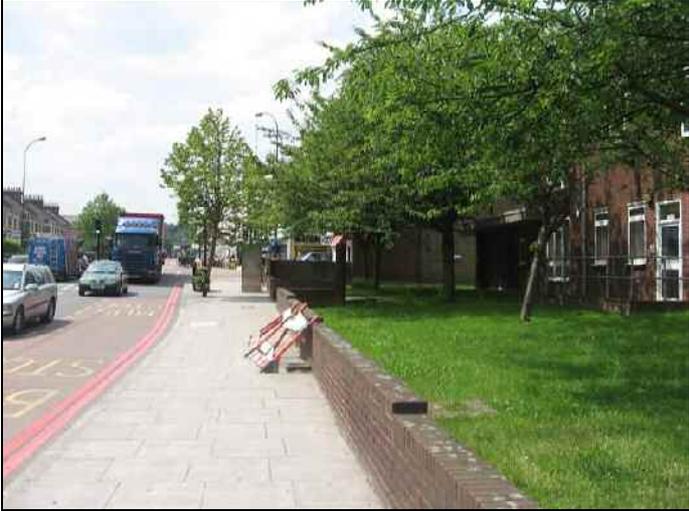
<p>A photograph showing a bus stop area on a sidewalk. The road is busy with fast-flowing traffic, including a large blue truck. The scene illustrates the impact of fast-flowing traffic on the environment at waiting areas.</p>	<p>Fast flowing traffic on the A205 causes poor air quality and noise pollution, reducing the quality of the environment at waiting areas such as PT12 (Bus stop E A205 northside, east of Brockley Rise).</p>
