# Transport for London

## PERS AUDITS 08/09 Phase Four

South – Lewisham, Greenwich,  
Bexley  
A205 Forest Hill Station to  
Catford Gyratory

### Final Report

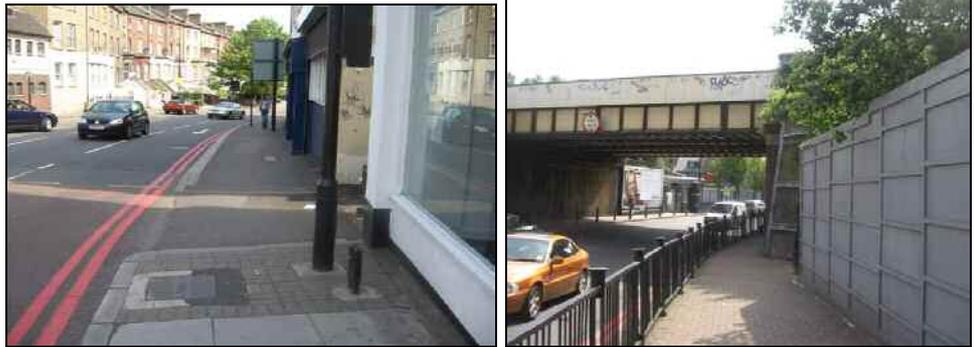
Descriptor	A205 southside from London Road to Waldram Place
Ref	L1
RAG & Total Score	-12
Comments	<p>The <u>permeability</u> of this link is <u>poor</u> owing to <u>poor kerbs</u> and <u>high traffic flows</u> along the A205, which is three lanes wide in places. Kerb stones along much of the link are not dropped but consist of between two to three <u>steps that need to be negotiated</u>.</p> <p>The link is located on a <u>considerable gradient</u> and is comprised of a <u>number of crossfalls</u> which increase the impact of the gradient. <u>Surface quality is also poor</u> with a number of <u>raised utility covers</u> and <u>undulations</u>. There are <u>no rest points</u> which will make traversing this link more uncomfortable for mobility impaired pedestrians. <u>Tactile information provision is also limited</u> along the link, which will reduce accessibility for sensory impaired pedestrians. There is a <u>useable tapping line</u> that will enhance legibility for sensory impaired pedestrians, although legibility in general is poor as there is <u>no pedestrian signage</u> on the link. <u>Sightlines are also poor</u> owing to a bend in the carriageway. Signage that is provided for motorists is, however, <u>likely to obstruct</u> and <u>reduce effective width</u>. Temporary</p>

<p>works under the railway bridge are also likely to obstruct pedestrian flow, although the <u>low volume of pedestrians</u> seen using this link suggests that pedestrian conflict should not be a problem.</p> <p>The <u>quality of the environment is poor</u>. This is largely the result of the impact of <u>high flows of vehicles and the associated noise and pollution</u>, but it is also caused in part by a number of <u>rundown frontages</u> on the link. These vacant buildings also serve to <u>reduce security perceptions</u>, which are generally good despite the <u>absence of visible formal surveillance measures</u>.</p>
Photographs

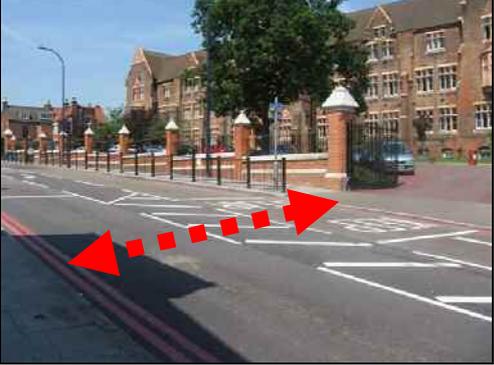
<p style="text-align: center;">C32</p>

Descriptor	Three informal crossings in the vicinity of Catford Gyratory: <ul style="list-style-type: none"> <li>• Informal across A205 outside St. Dunstan's College C32</li> <li>• Informal across A205 south of Glenwood Road C33</li> <li>• Informal across A205 west of the Catford Gyratory C35</li> </ul>		
Ref	C32	C33	C35
RAG & Total Score	-68	-21	-34
Comments	<p>C32 is an informal crossing of the A205 that is frequently used by pedestrians, particularly <u>students from St. Dunstan's College</u>. It is located on the general desire line, although there is <u>minimal scope for deviation</u> owing to <u>extensive guard railing</u> on the northern side of the crossing. <u>Pedestrian delay</u> is caused either by <u>traffic queuing across the crossing area</u>, or by <u>high volumes of fast moving traffic</u>. The crossing is on a <u>fairly steep slope</u>, but it <u>would not be suitable for sensory or mobility impaired pedestrians</u> regardless owing to the lack of provision. The surface of both the footway and carriageway are well maintained.</p> <p>C33 experiences <u>moderate pedestrian and vehicle flows</u>. <u>Vehicle speeds are generally low</u> as they tend to <u>queue across the crossing area</u> to enter the A217. There are <u>no dropped kerbs or provision for sensory impaired pedestrians</u> and so the ability of some pedestrians to use this crossing is compromised. The general lack of provision and good vehicle behaviour witnessed means that whilst pedestrians may experience delays to crossing <u>the informal crossing performs relatively well</u>.</p> <p>C35 the only form of provision is a <u>traffic island which can serve as a refuge</u>, although the <u>capacity of the traffic island is limited</u>, particularly with <u>bollards and a traffic light reducing its effective width</u>. <u>Pedestrians do not have priority</u> at the crossing, which experiences <u>heavy traffic flows</u>. This can lead to <u>delays and potentially hazardous crossing conditions</u> which are exacerbated by <u>sightlines being restricted</u> to the west by a bend in the road traffic. The <u>lack of dropped kerbs and tactile information</u> means that the crossing would be difficult for sensory and mobility impaired pedestrians to use even if they were able to negotiate the high traffic flows.</p>

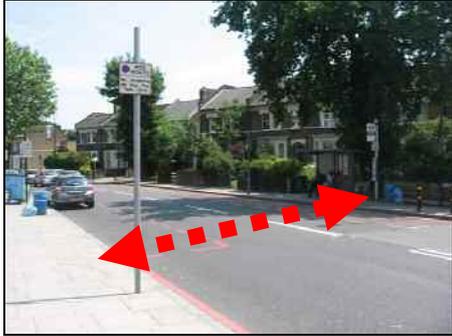
<p>C38</p> </div> <div style="text-align: center;">

<p>Descriptor</p>	<p>Five informal crossings to, from and between bus stops:</p> <ul style="list-style-type: none"> <li>• Informal across A205 from PT7 to parade of shops opposite C38</li> <li>• Informal across A205 from PT6 C43</li> <li>• Informal across A205 between PT5 and PT12 C45</li> <li>• Informal across A205 from PT4 to the garage and PT13 C47</li> <li>• Informal across A205 from PT15 to Westbourne Drive C52</li> </ul>				
<p>Ref</p>	<p>C38</p>	<p>C43</p>	<p>C45</p>	<p>C47</p>	<p>C52</p>
<p>RAG &amp; Total Score</p>	<p style="background-color: red; color: white; text-align: center;">-31</p>	<p style="background-color: red; color: white; text-align: center;">-49</p>	<p style="background-color: yellow; text-align: center;">-18</p>	<p style="background-color: yellow; text-align: center;">-28</p>	<p style="background-color: red; color: white; text-align: center;">-33</p>
<p>Comments</p>	<p>C38 has <u>no provision for pedestrians</u> despite being located on a desire line created by PT7 and the parade of shops opposite. There is <u>no demarcation for pedestrians in the crossing area</u> and those using the crossing are likely to be subject to <u>delay as a result of vehicle behaviour and high traffic flows</u>. The A205 is <u>relatively wide at this point</u> causing pedestrians to wait between lanes leaving them <u>vulnerable to traffic</u>. There is <u>good lighting provision</u> but <u>no dropped kerbs or tactile paving</u> to assist mobility and sensory impaired pedestrians.</p> <p>C43, which is located on a desire line between PT6 and PT11, suffers from the same problems as C38. The only notable difference is that a</p>

<p><u>tree on the northern side of the crossing may impede sightlines.</u> Whilst the street tree is unlikely to obstruct users its <u>roots have created severe undulations in the footway.</u> The <u>quality of the footway on the southern side of the crossing is also uneven,</u> which creates a number of possible <u>trip hazards.</u></p> <p>C45 lies on a desire line between PT5 and PT12 and is again very similar to C38. The main difference is that <u>dropped kerbs are accessible</u> at this crossing point, although they have not been provided for the purpose of crossing. It remains <u>unlikely, however, that mobility impaired users would be able to traverse this crossing.</u></p> <p>C47 is on the desire line between the garage, PT13 and PT4 and again experiences the same problems as C38. Like C45, however, <u>dropped kerb provision here is good</u> created by the garage and a private driveway. The <u>footway surface is adequate</u> although uneven in parts, and the presence of <u>a utility panel could potentially be a trip hazard.</u></p> <p>C52 experiences <u>high pedestrian flows</u> to and from the Co-op and PT15. <u>High volumes of traffic</u> are experienced at this informal crossing which is made particularly <u>hazardous owing to the proximity to several junctions.</u> <u>Vehicle behaviour is variable</u> and <u>traffic flows can block sightlines,</u> which makes the <u>lack of provision for pedestrians</u> and <u>poor space ownership</u> a concern. <u>Delay for pedestrians can be significant,</u> and pedestrians have been seen waiting in the middle of the wide stretch of carriageway to cross, leaving them <u>vulnerable to high traffic flows</u> on both sides. There are <u>some pedestrian barriers to the southside of the crossing area,</u> and these obstruct pedestrian flow. <u>Bollards on both sides of the crossing also obstruct.</u> <u>Vehicles queuing across the crossing area</u> are often the main cause of obstructions however, with <u>pedestrians seen weaving between stationary vehicles.</u></p> <p>There are <u>no dropped kerbs on the southern side,</u> but the entrance to the Co-op provides informal dropped kerb access to the northern side. This crossing is <u>not suitable for mobility or sensory impaired users</u> however.</p>

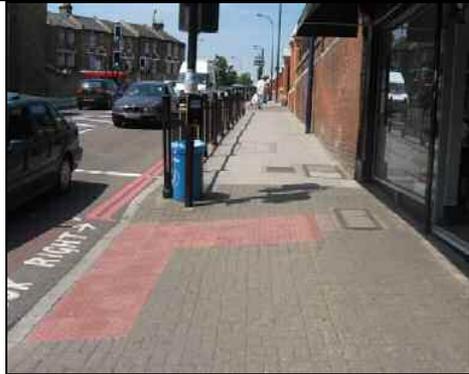
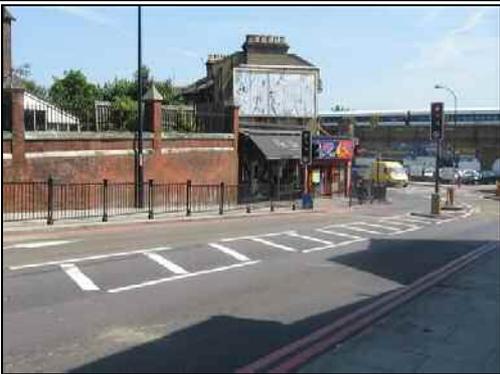
Descriptor	St. Dunstan's College to Catford Bridge Station
Ref	R1
RAG & Total Score	<b>-26</b>
Comments	<p>The only parameter for which the route obtained a positive score was directness. <u>Permeability was deemed to be poor</u> owing to the <u>lack of opportunities to cross the A205 and A217</u>, <u>poor sightlines</u>, and the generally <u>poor condition of dropped kerbs</u>. <u>Tactile information provision was also thought to be poor</u>, which, combined with the <u>limited use of colour contrast</u>, has resulted in relatively <u>poor legibility</u>. The <u>lack of rest points</u> along the route could further <u>restrict the ease of use</u> by certain groups of pedestrians.</p> <p><u>Safety from vehicles was deemed to be poor</u>, which was contributed to by <u>high levels of vehicle noise</u> and the <u>potential for conflict at crossings</u>. There were also <u>concerns raised over personal security</u> as <u>sightlines and visibility are restricted in places</u>, and the <u>quality of frontages was considered to be poor</u>. The <u>absence of occupied frontages</u> also contributed to the assignment of a negative score for personal security,</p>

and was also felt to <u>reduce the quality of the environment</u> , which is very much <u>dominated by vehicles</u> .	
Photographs

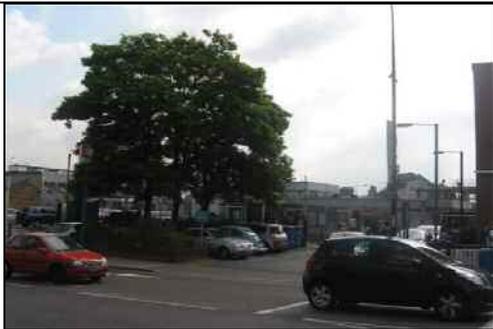
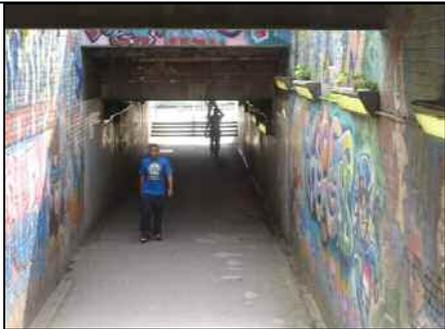
Descriptor	Forest Hill Station to nearby bus stops.	
Ref	IS1	
RAG & Total Score	-25	
Comments	<p>This interchange Space allows people to continue their journey from the train to buses. <u>The space is busy and has some signage however it is inconsistent and lacking for those people exiting from the western side of the station. At this exit there is no map showing the location of bus stops and their destinations. Users of the interchange space are not helped to feel comfortable with no seating available at the station or at bus stop 'F' although there are toilets at the station. The space is not well maintained and has a run down feel. There is an abundance of litter around and although there are planters for some landscaping, many are neglected and no longer enhance the area. Users wanting to access bus stop 'H' are directed towards a subway which although has CCTV is likely to feel unsafe at night.</u></p>

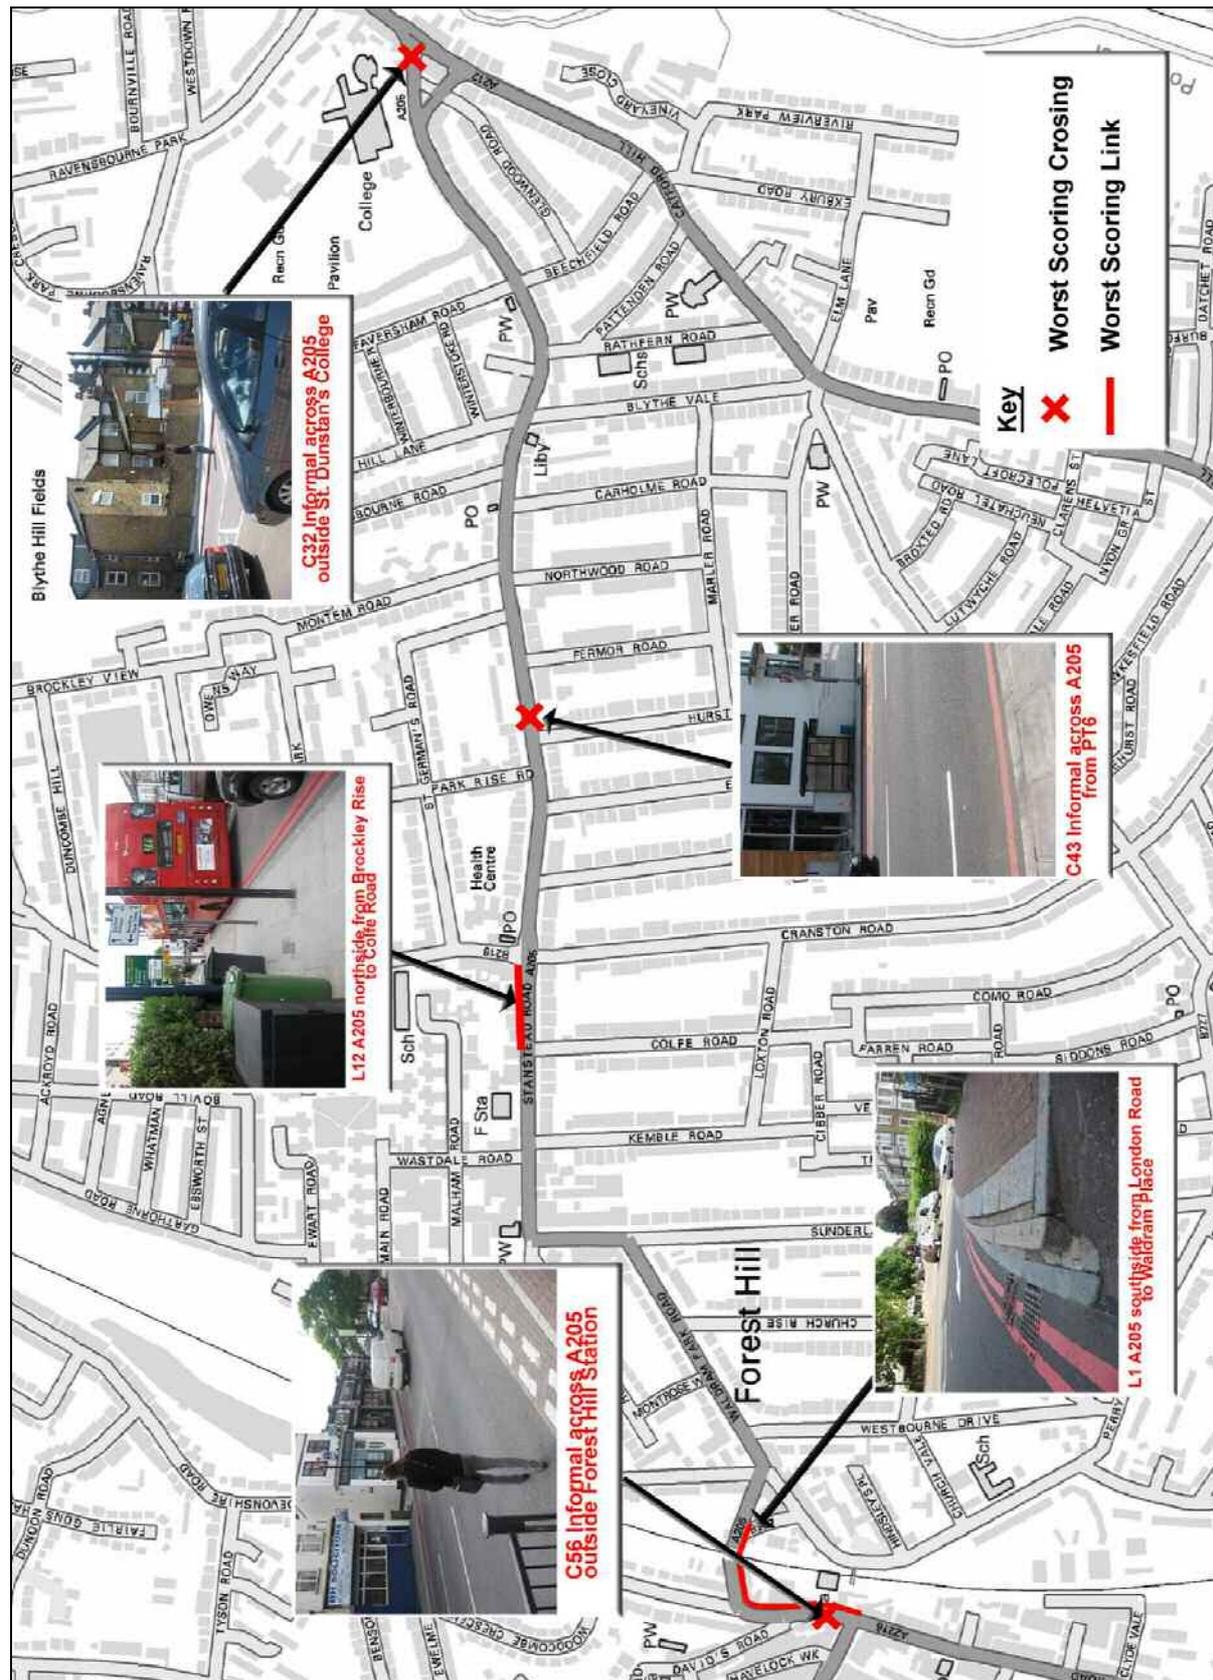
Figure 4.17: Summary map of components that are of key concern

- IS1 obtained a negative score, but it was not low enough to receive a red RAG score. Inconsistent and inadequate signage, a lack of seating and an intimidating subway all contribute to the negative score. Levels of maintenance were also deemed to be poor. This is in part owing to an abundance of litter, poorly maintained landscaping features, and a general sense of neglect. This can have a negative impact upon safety perceptions.

Table 4.31 and Figure 4.17 summarises the key audit components within the A205 Forest Hill Station to Catford Gyratory which require the most attention in terms of pedestrian provision.
